Montara Blowout

**What went wrong? What are the lessons for
industry and regulators?**

Jane Cutler
Chief Executive Officer
October 2010

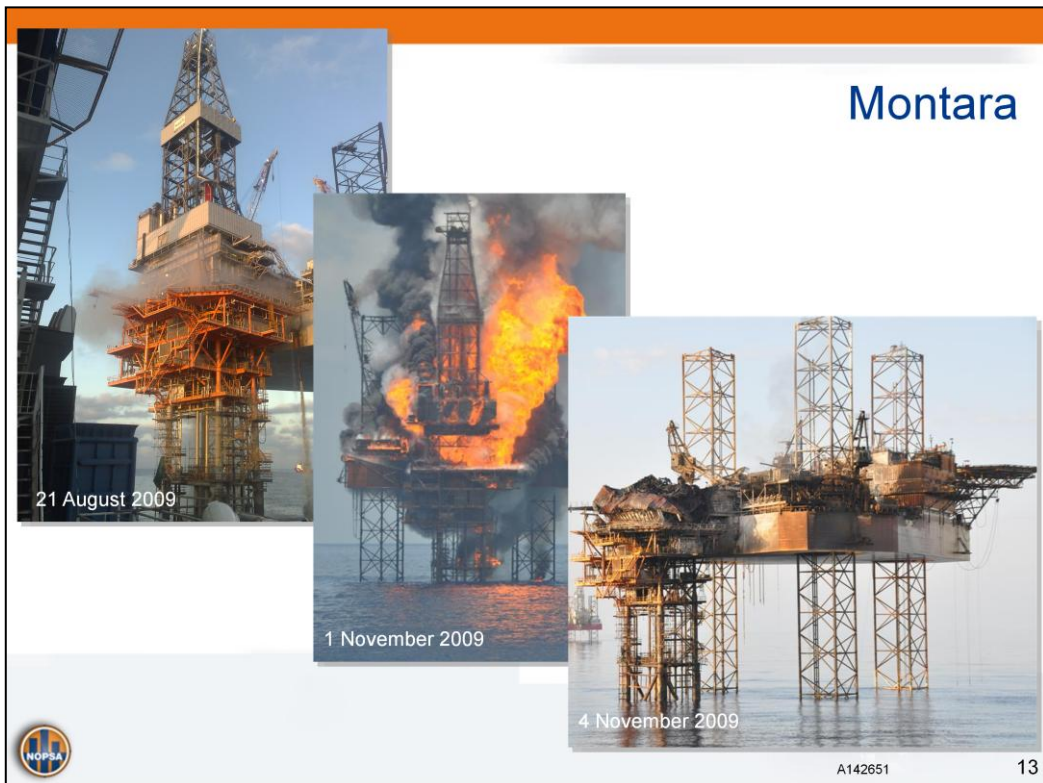
This is an import series of pictures, the one on the left is taken from the Java Constructor which was anchored alongside the Montara WHP when the blowout first occurred. The safety case and the day to day planning of construction and other activities on the Java did not contemplate the vessel being located alongside live hydrocarbon activities. The You can see a hardhat in the foreground of that picture and the gas / condensate release from the platform.

We are extremely fortunate that there were not fatalities or serious injuries.

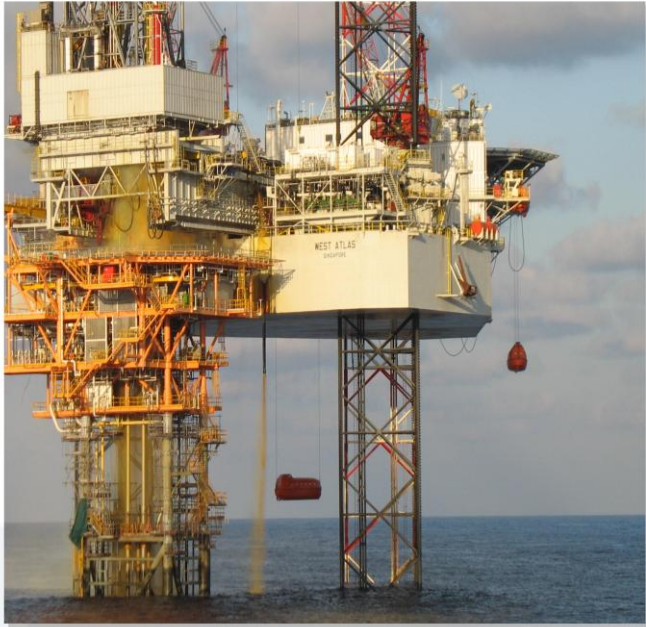
Well Integrity
=
**Pressure
Containment**
=
Barriers

The blowout was the result of systemic failures by the operator to properly manage the integrity of the well as a whole.

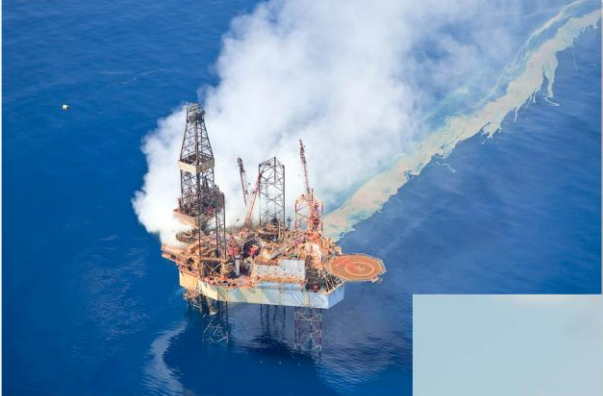
Root Cause:
Systemic failure of management systems, non-compliance with operating procedures

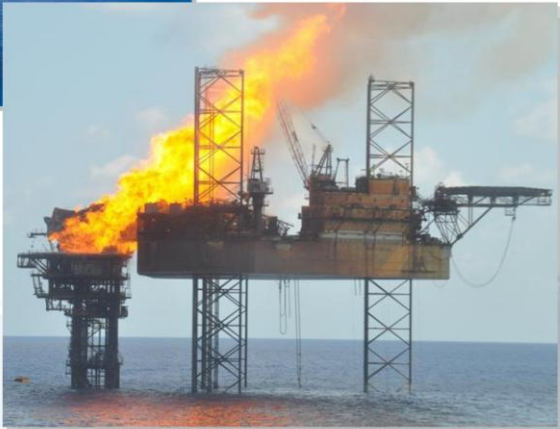
Immediate Cause:

Primary cementing integrity failure

- The immediate cause was a poor cement job and failure of the float valves
- The root cause was a systemic failure of management systems and non-compliance with operating procedures. The standards processes and procedures seem to have been in place but not adhered to for some reason.
