Montara Blowout

**What went wrong? What are the lessons for
industry and regulators?**

Jane Cutler
Chief Executive Officer
October 2010

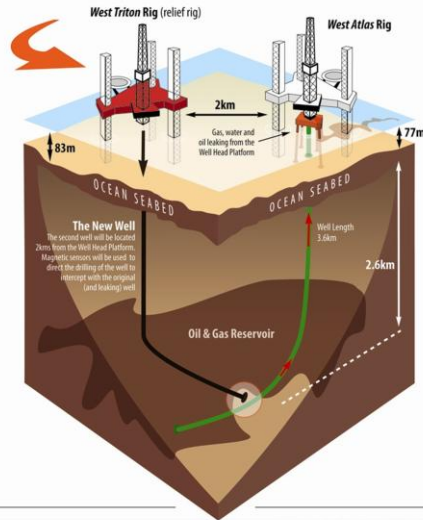
Well Repair Plan

How the Montara Platform leak will be stopped

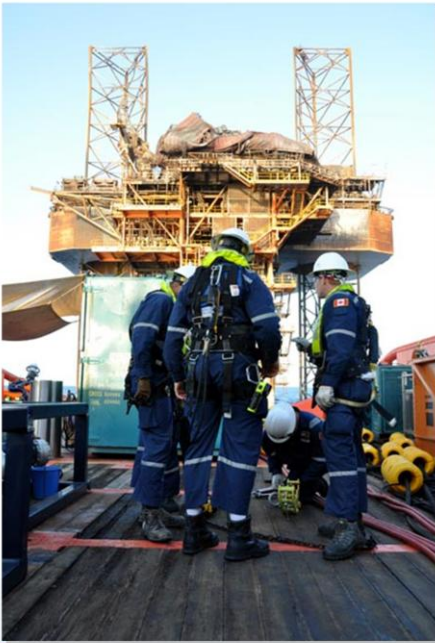
Response – Well Salvage – West Atlas

- November 2009:
 - Personnel board West Atlas
 - Personnel board WHP
 - 320 bbl cement pumped via relief well into H1 well
 - Packer set in H1 well, pressure test not completed
 - plugging activities completed
- Sep-Oct 2010:
 - Salvage commenced with Jascon 25

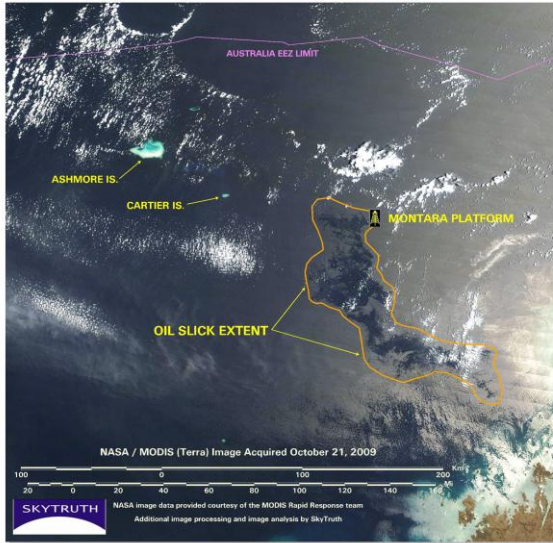
Response – oil spill

- National Plan activated
- 21 August – 3 December: AMSA led response
- Objective – protection of environmentally sensitive areas
- 184,000 l dispersant used
- 844,000 l oily water collected, (493,000 l was oil or oil emulsion) over 35 days
- Shore clean up plans not required
